District Wide Master Plan & Ft. Bliss Campus Design

PART B | CAMPUS ANALYSIS
SEPTEMBER 17, 2014

Campus Analysis

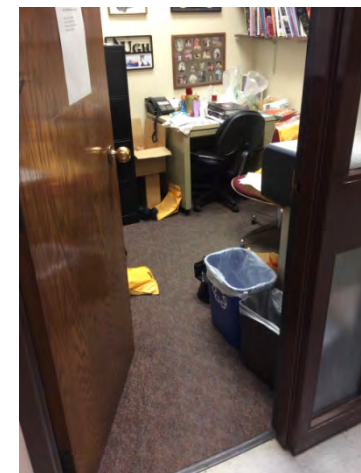
1. No single defined main entrance to the campus.
2. Potential for additional exterior hangout space and better existing.

3. Non-code compliant vertical circulation elements.
4. Restrooms are not code compliant.
5. Offices are small and crowded potential for no ADA accessibility.
6. Code violations such as non compliant drinking fountains, fire extinguishers, sinks and door hardware.
7. No large meeting space; potential to improve ex. hangout/study spaces.
8. Sound transfer between student dining and student assembly through existing glass wall.
9. Improve on greeting spaces.

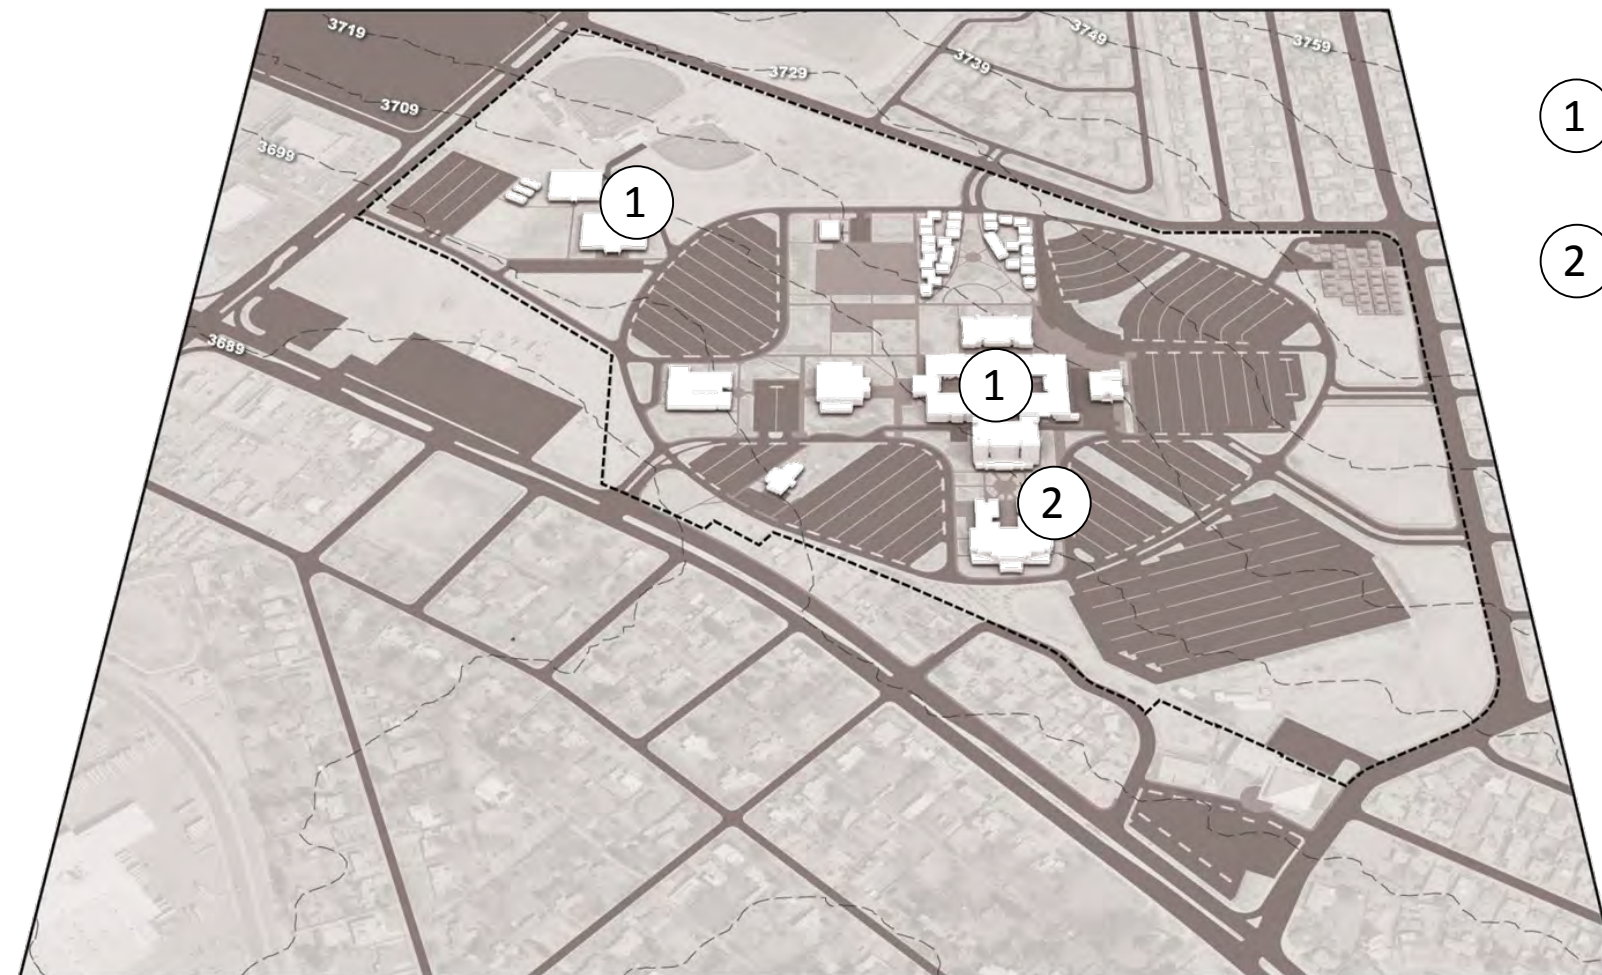
- Chillers w/ Ice storage. Cooling capacity 1875 tons (3 x 625 ton chillers)
- Boilers. Heating capacity 12,000 mbh (3 x 4000 mbh boilers)
- Large Custom Air Handling Units
- Elect Primary metering/site distribution

Priority 1-3 Deficiencies: \$17.8M

- Cooling = 1 x 625 ton Redundant Chiller
- Heating = at Capacity, short by 5000 mbh
- Elect demand readings required to determine capacities

- 1 Install Fire Sprinklers
 - 2 HVAC System Replacement
- Replace defective FA system devices, egress lighting, general lighting, electrical panelboards/equipment, campus-wide

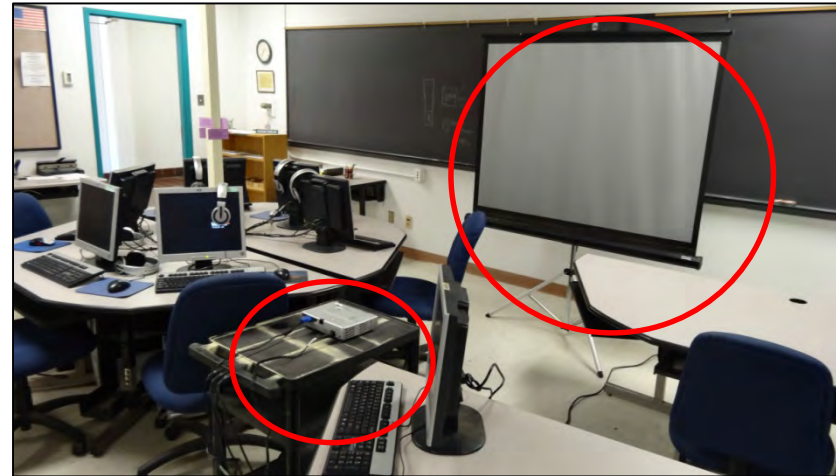
1. Observed mobile equipment being used as permanent presentation and instruction setups.
2. Noted high use of informal student gathering spaces where technology infrastructure would be useful.
3. Abandoned or unused TVs in common areas.
4. No common enterprise-wide digital signage system.
5. Pockets of innovation exist across campuses as seen in the 3D image/gaming lab.
6. No digital connectivity in classroom to support newer walk-in devices (Laptops, tablets, etc) for presentation.
7. No network access to installed projector for remote support.

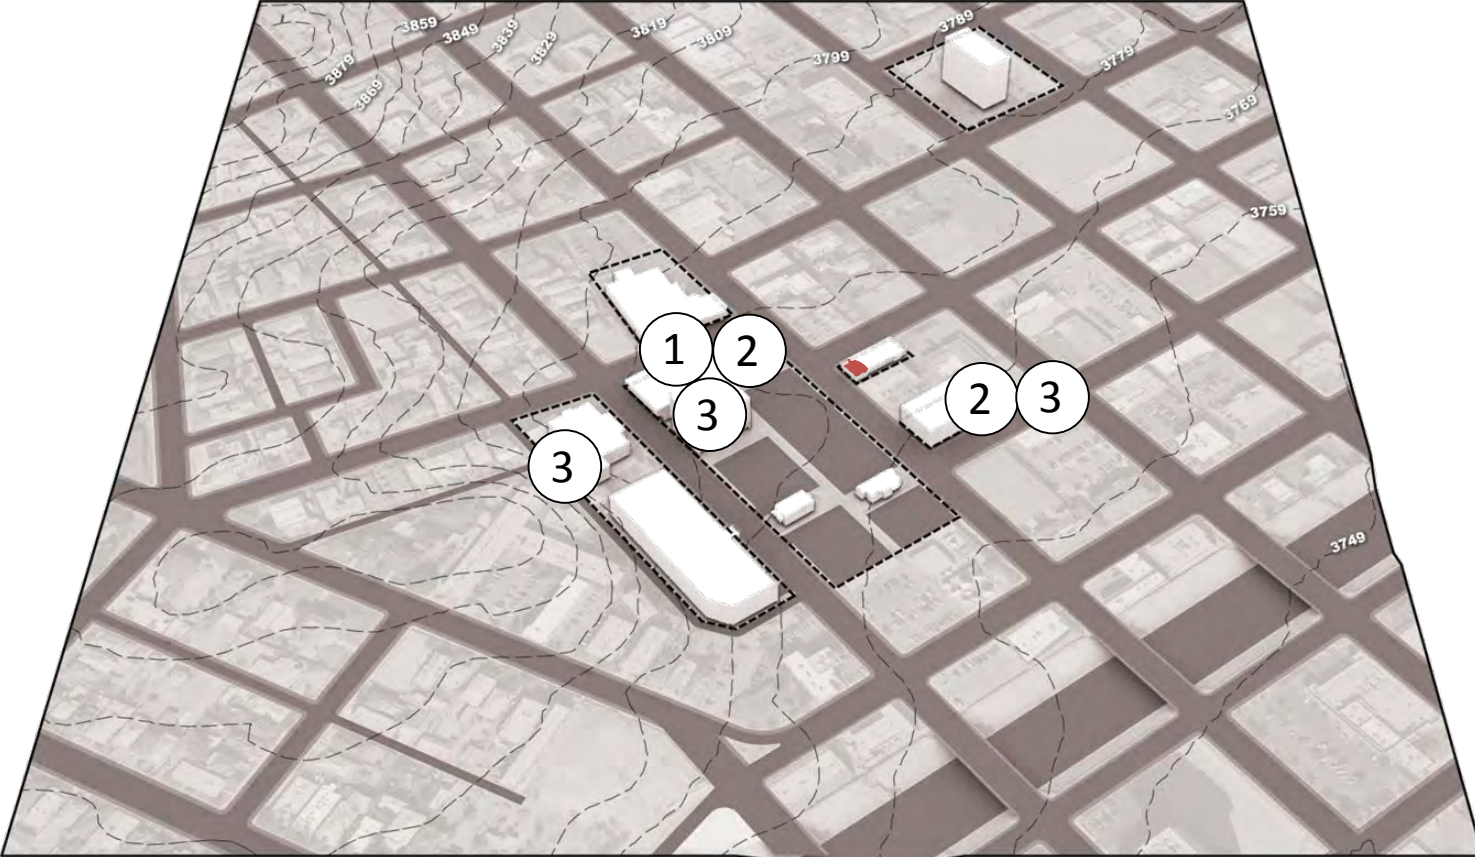
- Multiple Types of Chillers, Boilers
- Air handlers, Fancoil Units
- Individual Utility metering at Each Building

Priority 1-3 Deficiencies \$7.5M

- Main Bldg. Cooling – 50 tons
- Main Bldg. Heating – 840 mbh
- Electrical Capacities to be determined from Utility Co. Peak Demand Data

- 1 Install Fire Sprinklers
- 2 Replace damaged /defective lighting, egress lighting, panelboards, FA panels and devices
- 3 Complete system replacement (chiller redundancy)

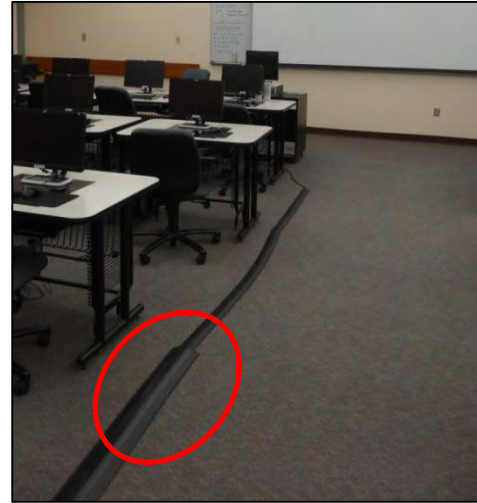
1. Older infrastructure creates challenges - Observed Power, Network, and AV extension when wall outlets or a floor box would provide proper access.
2. Pendant lighting fixtures interfere with sightlines to projection screen.
3. Noted AV-related theft issues.
4. CPUs on floors in some labs creating possible dust or maintenance issue.
5. Noted that some classrooms lack instructional technology.
6. Discovered duplicate instructional technology in some rooms (i.e. equipped smart cart in an equipped smart classroom).
7. Lack of wireless network access within simulation rooms. One control room to serve the entire program.

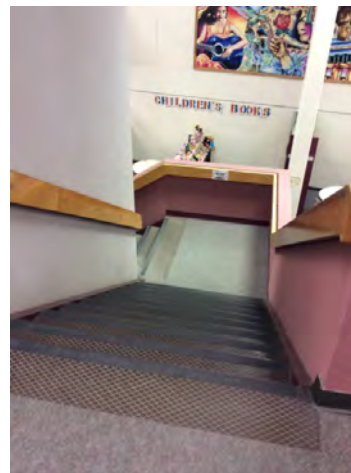
5. Furniture needs replacement .
6. Code violations such as door hardware, restrooms, handrails and stairs.
7. Stage is not ADA accessible.
8. Potential to utilize interior lobby/mall for improving study/hangout space.
9. Small classrooms.
10. Improve department signage/identification.

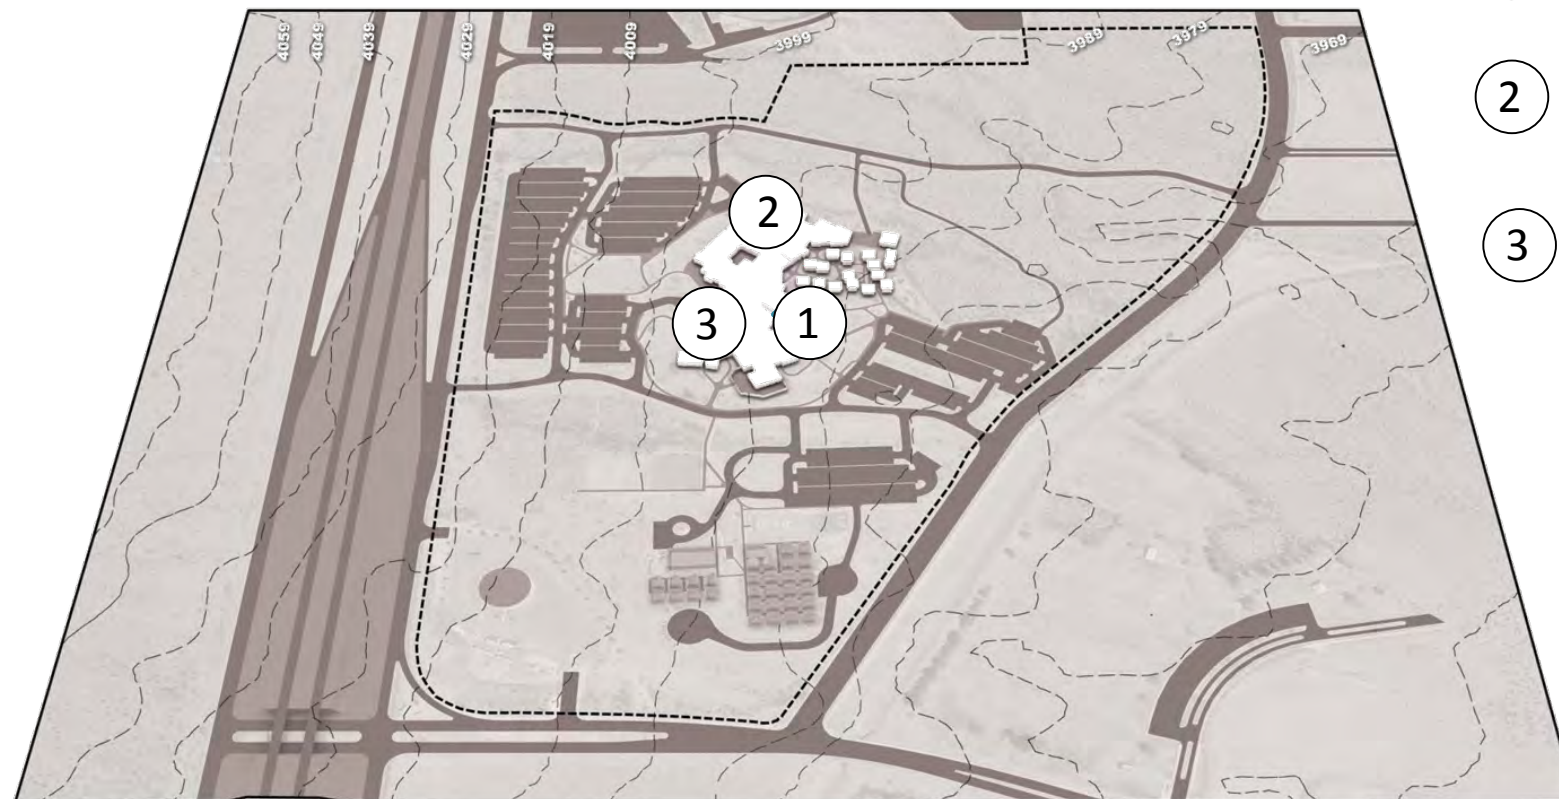
- 2 Chillers (600 tons) w/ Ice Storage, Boilers
- Fan Room & Roof Mounted AHUs
- Individual Utility metering at Each Building.

Priority 1-3 Deficiencies \$6.6M

- Cooling - 150 tons (Redundancy)
- Heating – at Capacity, Short
- Electrical Capacities to be determined from Utility Co. Peak Demand Data

- 1 Install Fire Sprinklers
- 2 Air Handler Replacement
- 3 Replace/upgrade / add FA systems, replace defective egress lighting, security devices, add GFCI recepts

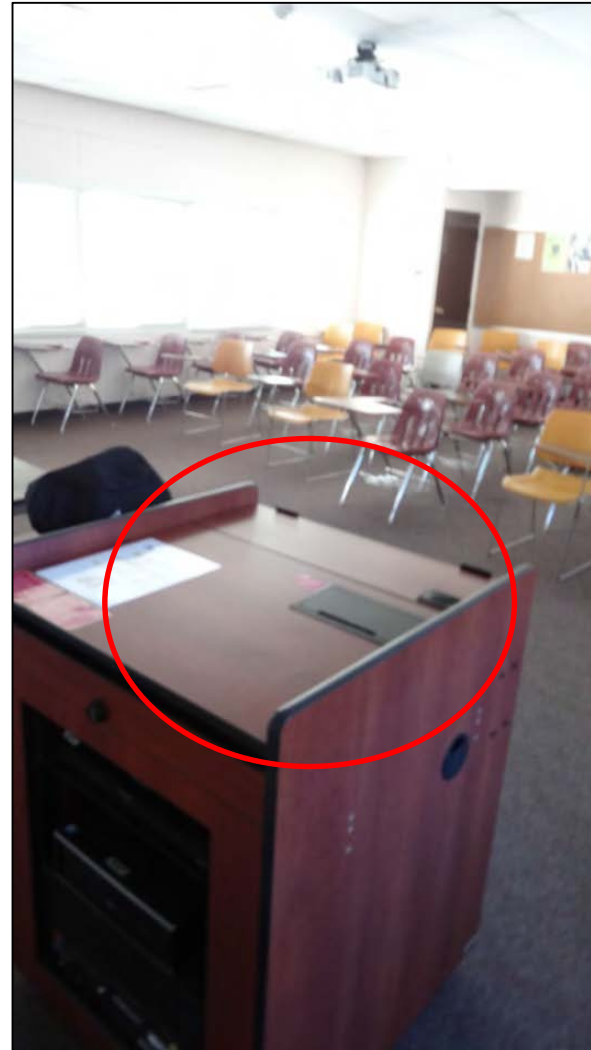
1. & 2.

1. Missing local computer monitor in several rooms.
2. Fixed chairs do not support collaboration in many classrooms.
3. Wireless access is limited across the campus including in portables.
4. Theater/auditorium utilizes end-of-life and end-of-support equipment.

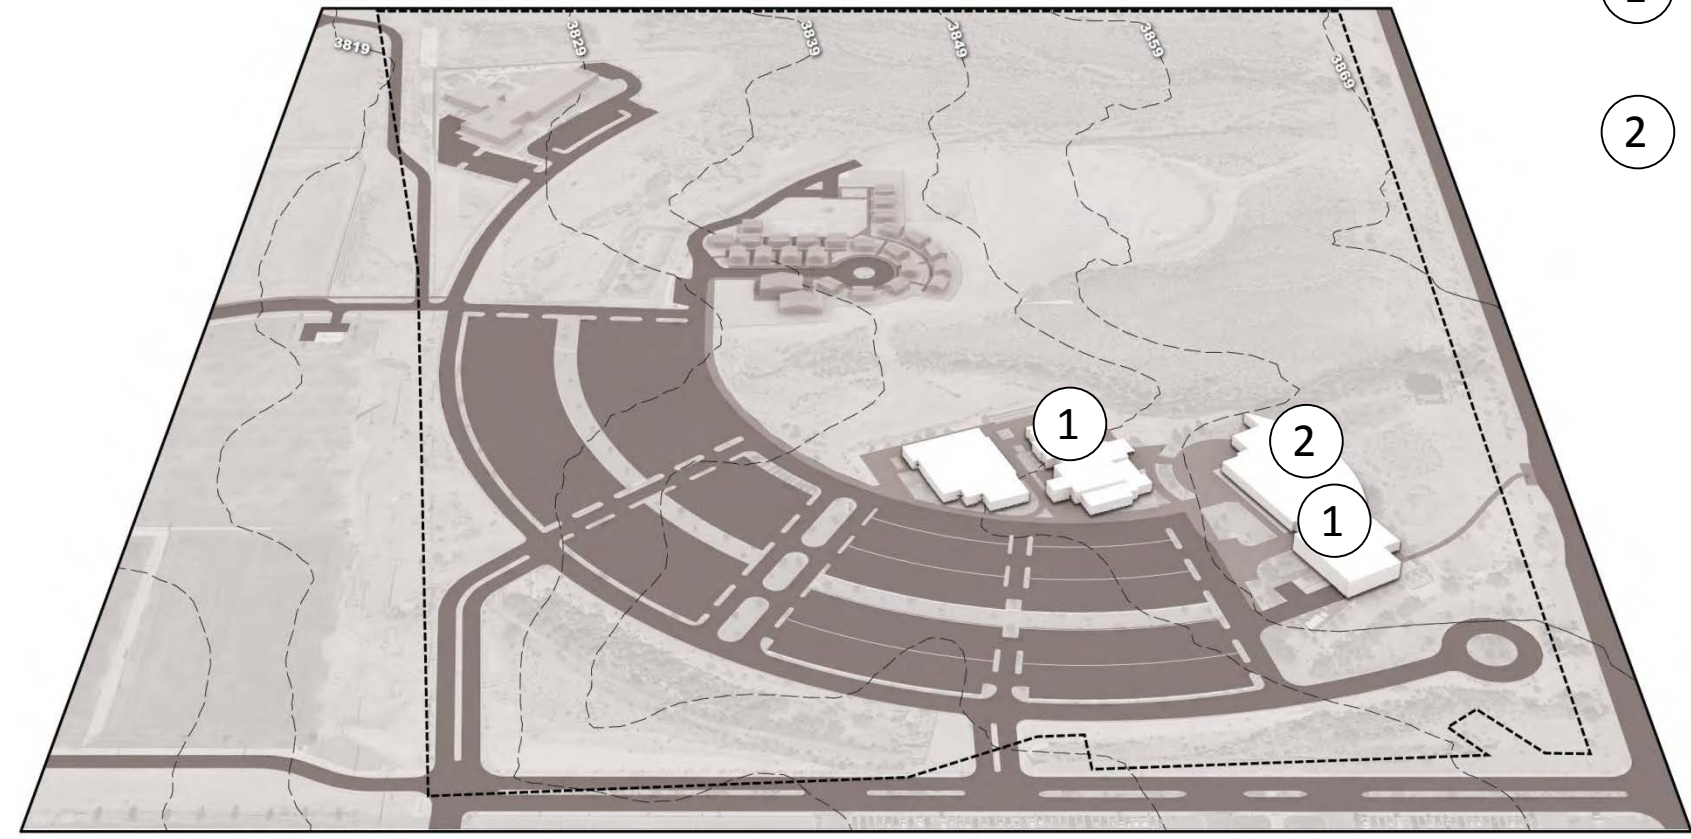
- Chiller, Boiler, Air Cooled Chiller
- Air Handling Units
- Individual Utility metering at Each Building. Elect systems generally in good condition

Priority 1-3 Deficiencies \$609K

1 HVAC Chiller & Plant Redundancy

2 Replace roofing

Replace defective FA system devices, exit signs, and lighting fixtures campus-wide

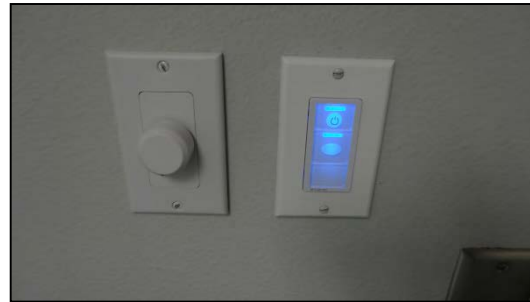
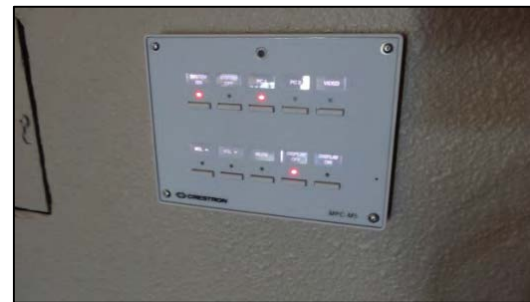
1. Standard smart rooms have a common user interface for control. Non-standard rooms have different control interfaces and unsupported AV equipment.
2. Digital AV connectivity (HDMI) needed in all classrooms to support newer laptops and devices.
3. Observed power poles obstructing sightlines in some teaching spaces.
4. Large number of printers across labs and classrooms would benefit from tracking utilization to reclaim costs and reduce waste.
5. Some computer labs running Windows XP (unsupported).
6. Existing Distance Ed videoconferencing equipment across multiple rooms and campuses no longer used.

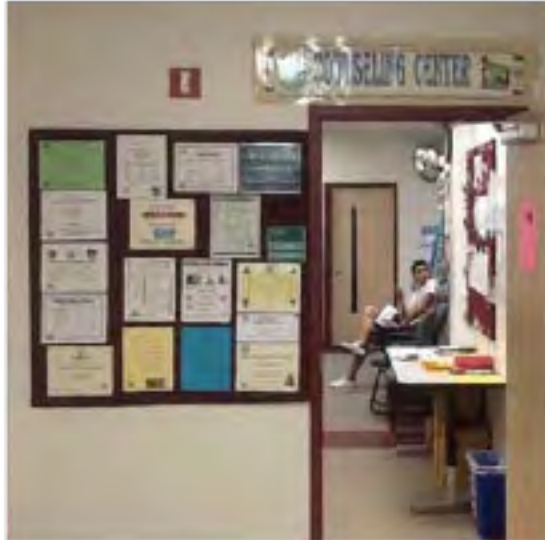
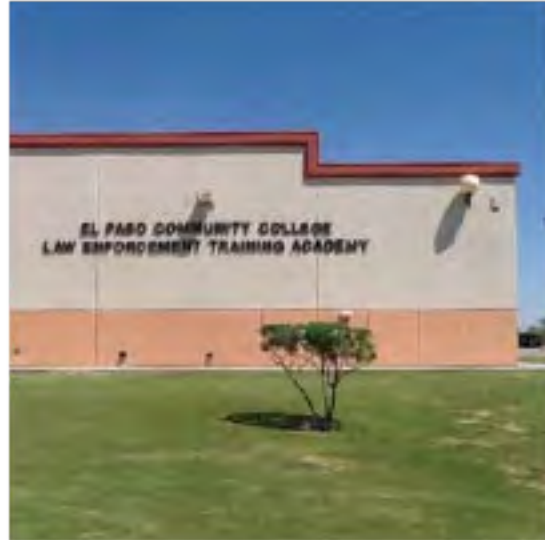
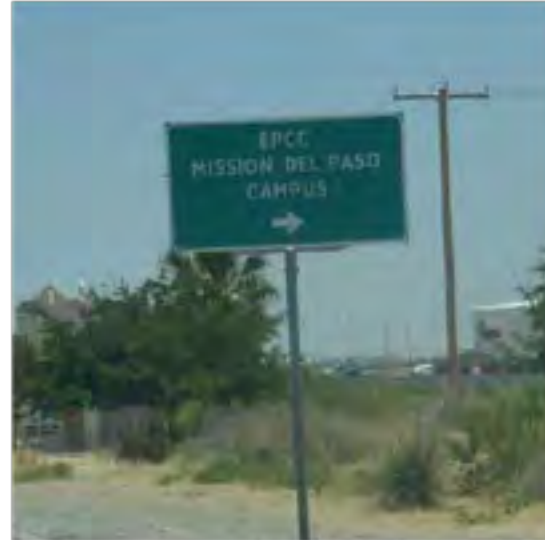
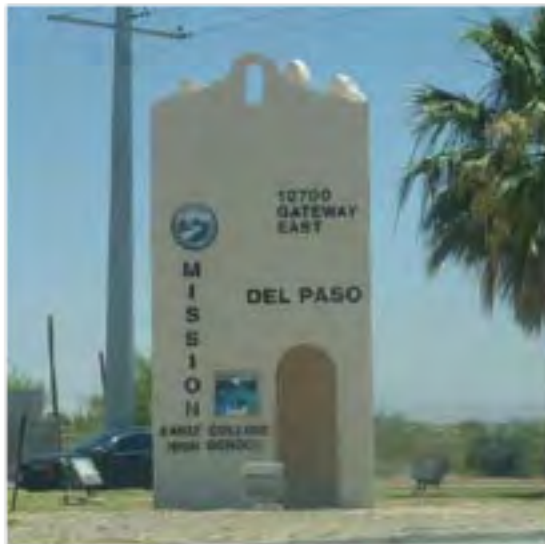
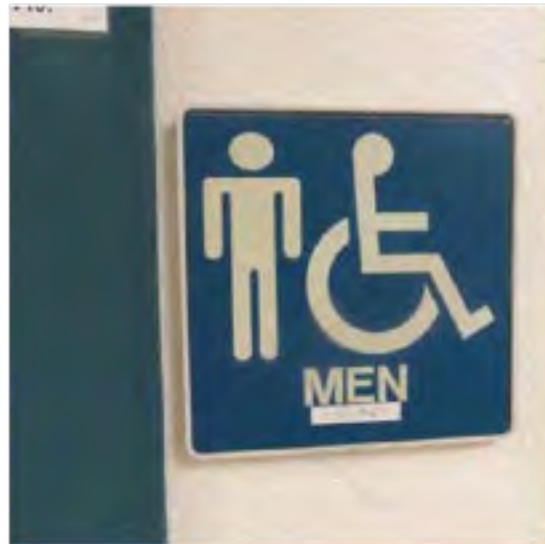
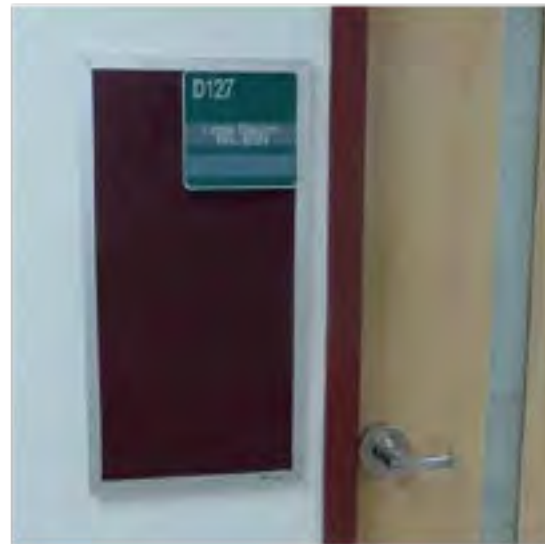
- The campus is small but not easily navigated.
- Like all campuses, directional signage could help aid first time visitors.
- The campus has a substantial main identity, but could use a reorganization of identity and symbols within the sign structure.
- For example, will the campus identity be the primary and the district identity hold a secondary position on the monument sign? This is typical of all campuses.
- Observed areas where 2 or more signs were identifying one room or communicating multiple messages. This leads to confusion and a plethora of handmade paper signs.
- A system of sign requisitions that helps the office, department, administration, etc. monitor the amount and the messages for signs would help eliminate over signing an area.

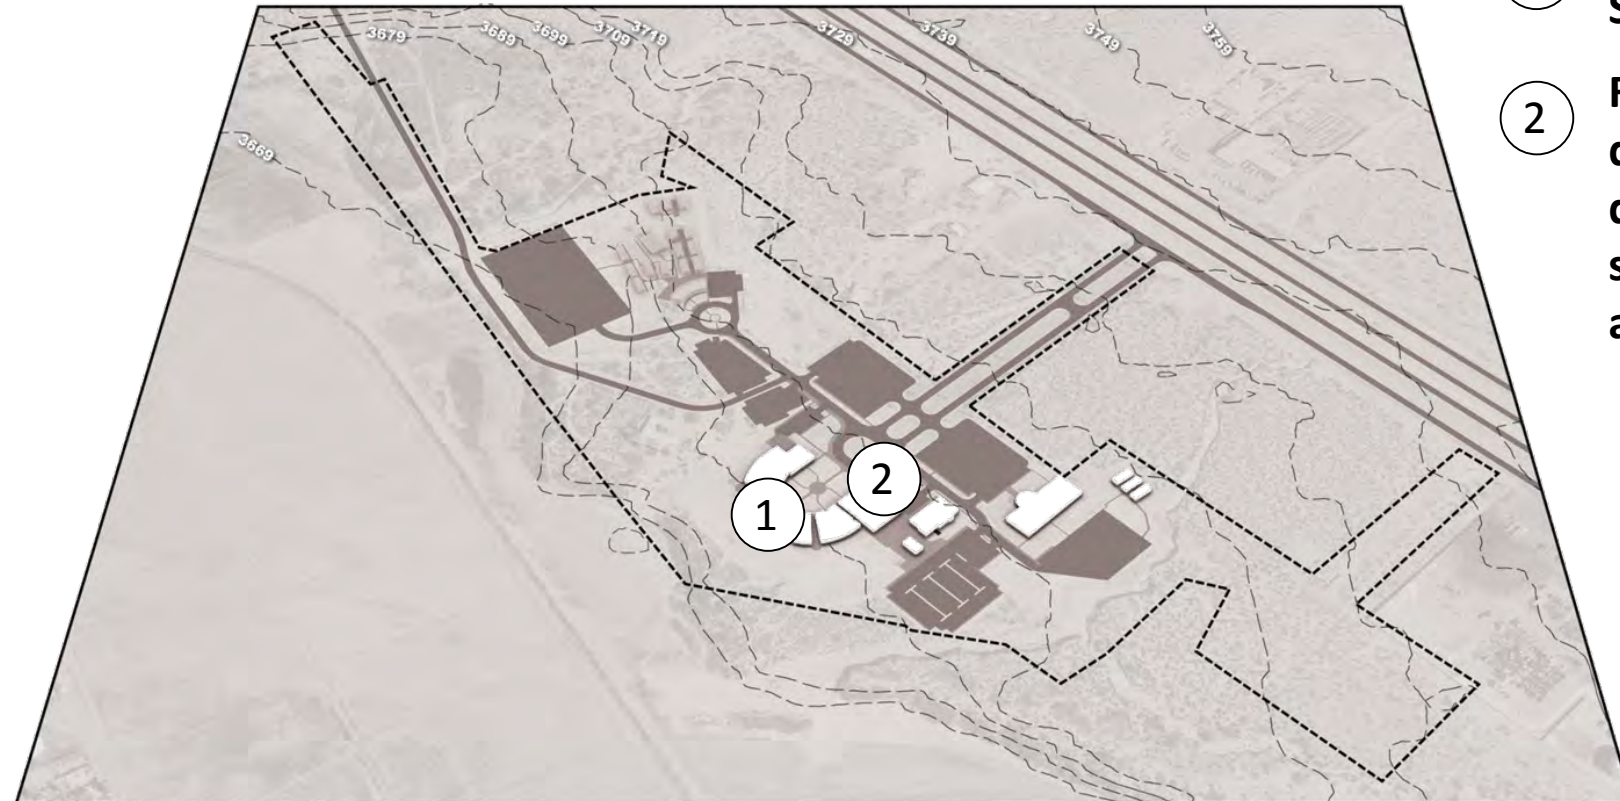
- 2 Chillers (250 + 99 tons), 1 Boiler (1167 mbh)
- Custom Air Handling Units
- Existing 1000A, 480/277V SES at Physical Plant serves all campus building except Bldg E.

Priority 1-3 Deficiencies \$1.9M

- Cooling – 150 tons, Redundant Chiller
- Heating – at Capacity, Short 1637 mbh
- Estimated Electrical service capacity at Physical Plant: 500KVA (To be verified with utility company peak demand data.)

- 1 Install Fire Sprinklers
- 2 Replaced damaged/defective FA system devices and lighting
