District Wide Master Plan & Ft. Bliss Campus Design

PART B | CAMPUS ANALYSIS
SEPTEMBER 17, 2014

Campus Analysis

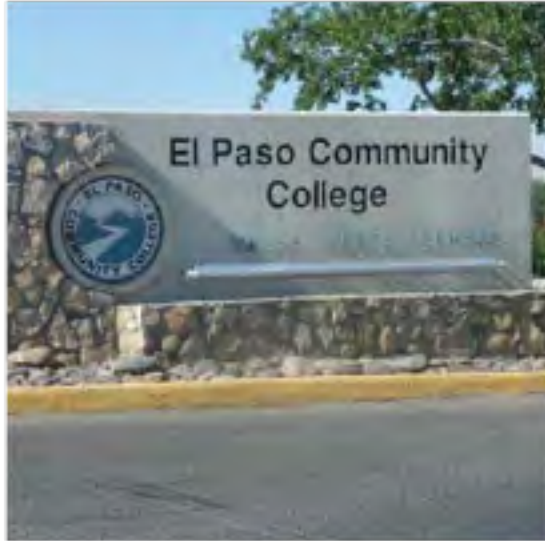
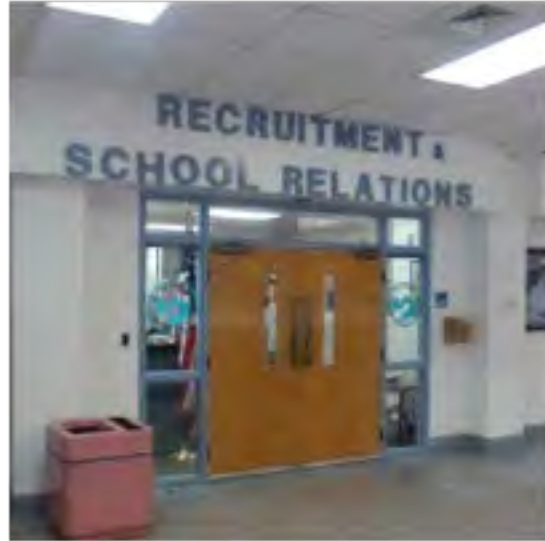
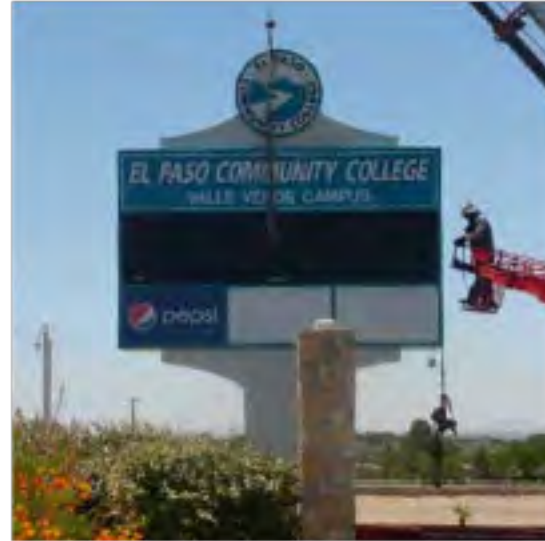
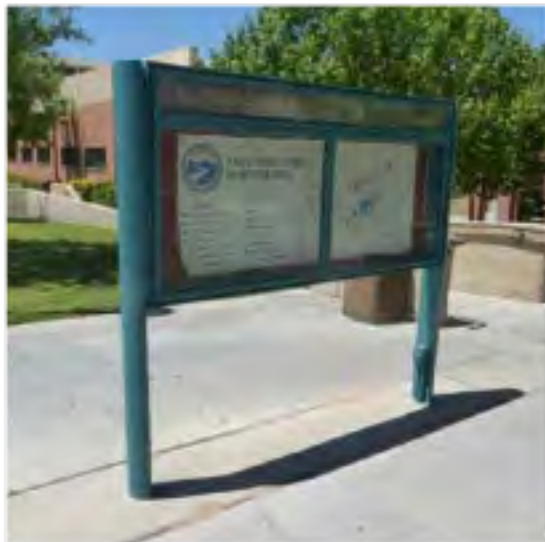
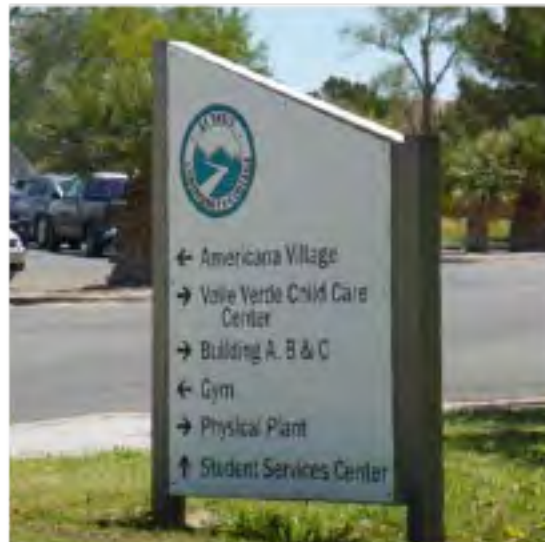
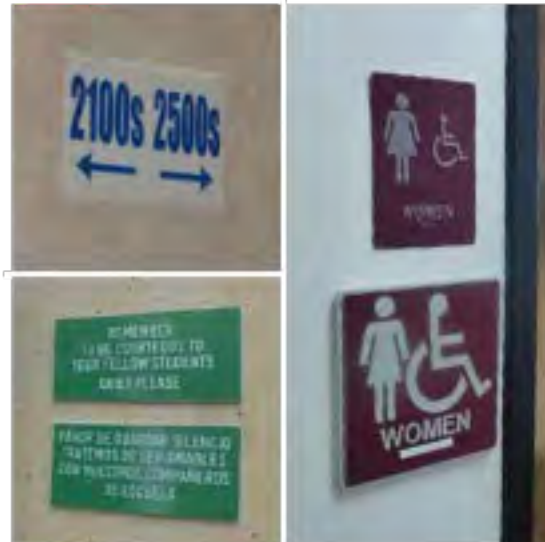
- In many cases, 2 or more signs identifying one room or communicating messages
- Lack of a hierarchy of elements to identify destinations
- Porous campus entry and several inner rings for parking make for complex wayfinding
- Desire to better project the EPCC “brand” and welcome community into campus
- Interior signage does exist but the messages may not be current or they are paper print outs attached to walls
- High school feeds into the campus, requiring significant pedestrian wayfinding
- Bus stops require signage to help direct individuals on foot with minimal car and pedestrian traffic conflict

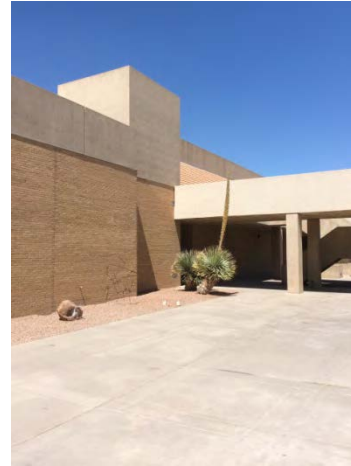
1. No single defined main entrance to the campus.
2. Potential for additional exterior hangout space and better existing.

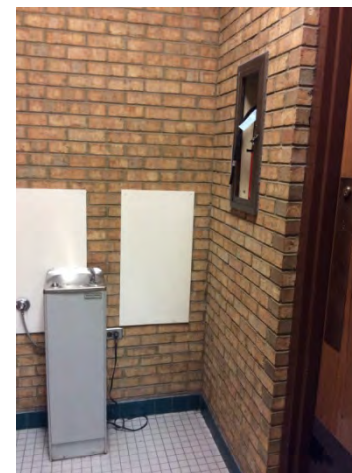
3. Non-code compliant vertical circulation elements.
4. Restrooms are not code compliant.
5. Offices are small and crowded potential for no ADA accessibility.
6. Code violations such as non compliant drinking fountains, fire extinguishers, sinks and door hardware.
7. No large meeting space; potential to improve ex. hangout/study spaces.
8. Sound transfer between student dining and student assembly through existing glass wall.
9. Improve on greeting spaces.

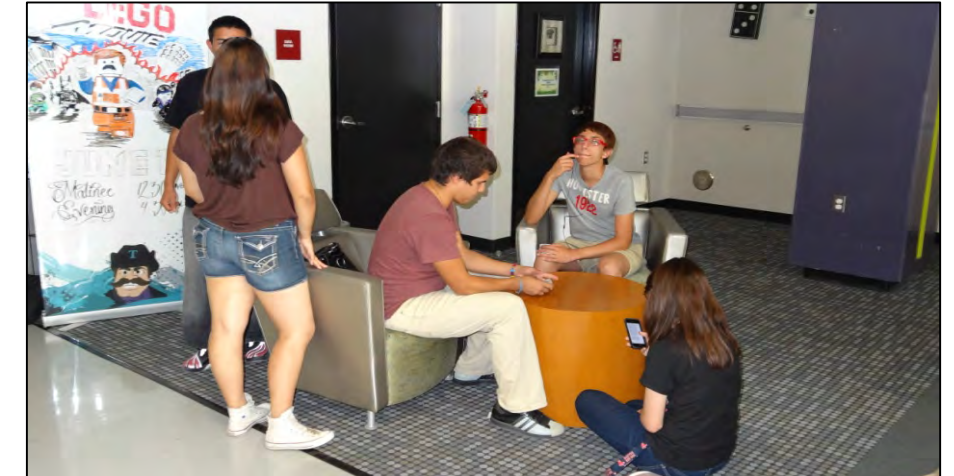
1. Observed mobile equipment being used as permanent presentation and instruction setups.
2. Noted high use of informal student gathering spaces where technology infrastructure would be useful.
3. Abandoned or unused TVs in common areas.
4. No common enterprise-wide digital signage system.
5. Pockets of innovation exist across campuses as seen in the 3D image/gaming lab.
6. No digital connectivity in classroom to support newer walk-in devices (Laptops, tablets, etc) for presentation.
7. No network access to installed projector for remote support.

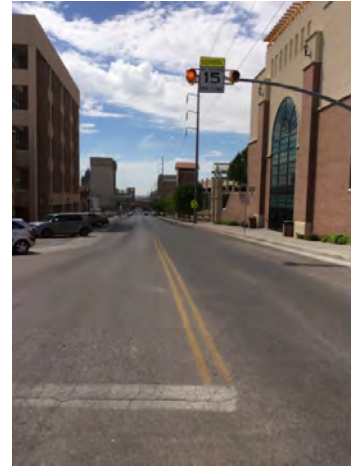
1. No one defined main entrance to the campus or building connection.
2. Drainage flooding problems
3. Lack of landscape/maintenance.

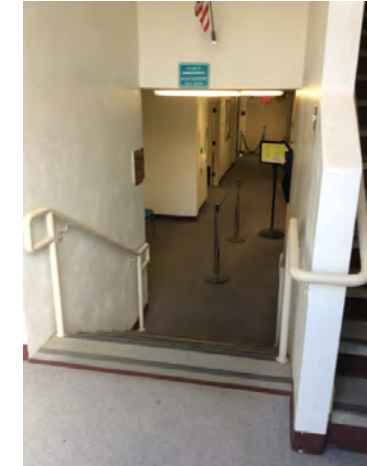
4. Small entry lobby at Student Service
5. Non-code compliant vertical circulation elements.
6. Some restrooms are not code compliant.
7. Small offices; accessibility issue.
8. Improve on lighting and furniture at small study areas and potential for additional seating.
9. Potential for large meeting space.
10. Small student activity area.

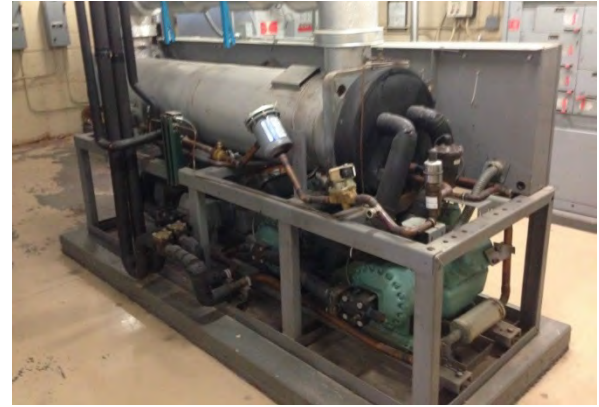
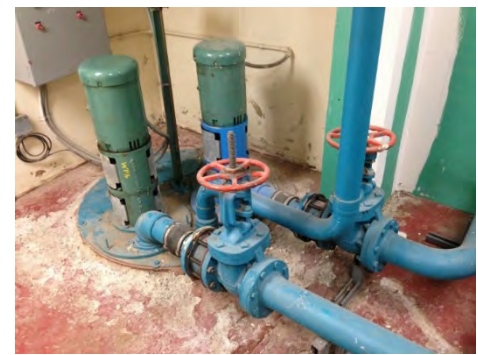
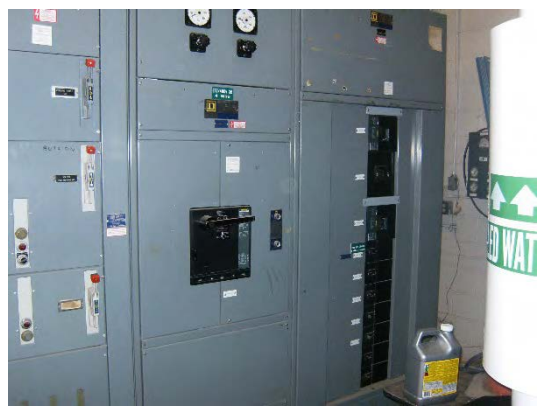
Existing Conditions

- Multiple Types of Chillers, Boilers
- Air handlers, Fancoil Units
- Individual Utility metering at Each Building

- 1 Install Fire Sprinklers
- 2 Replace damaged /defective lighting, egress lighting, panelboards, FA panels and devices
- 3 Complete system replacement (chiller redundancy)

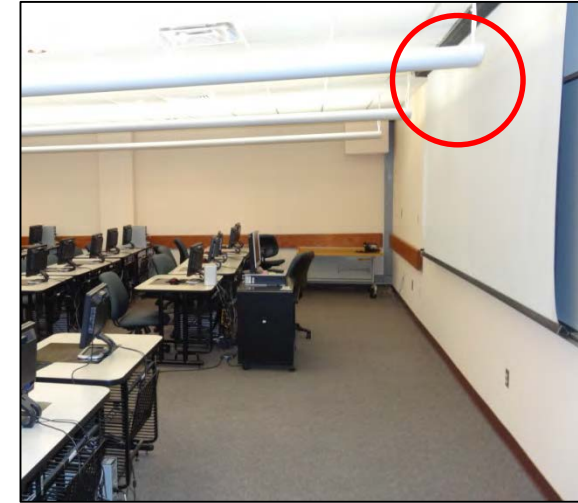
1. Older infrastructure creates challenges - Observed Power, Network, and AV extension when wall outlets or a floor box would provide proper access.
2. Pendant lighting fixtures interfere with sightlines to projection screen.
3. Noted AV-related theft issues.
4. CPUs on floors in some labs creating possible dust or maintenance issue.
5. Noted that some classrooms lack instructional technology.
6. Discovered duplicate instructional technology in some rooms (i.e. equipped smart cart in an equipped smart classroom).
7. Lack of wireless network access within simulation rooms. One control room to serve the entire program.

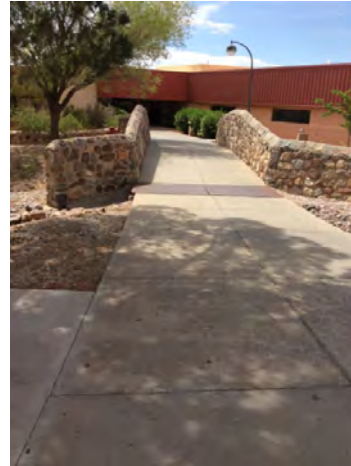
1. No defined exterior building entries or front entrance
2. “Desire” paths created in landscape; potential for student trails/paths.
3. Drainage flooding problems
4. Landscape requires maintenance; potential for exterior usable spaces.

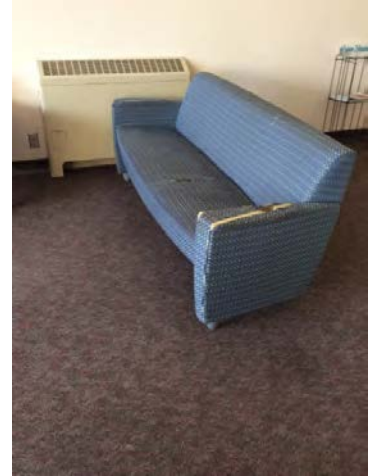
5. Furniture needs replacement .
6. Code violations such as door hardware, restrooms, handrails and stairs.
7. Stage is not ADA accessible.
8. Potential to utilize interior lobby/mall for improving study/hangout space.
9. Small classrooms.
10. Improve department signage/identification.

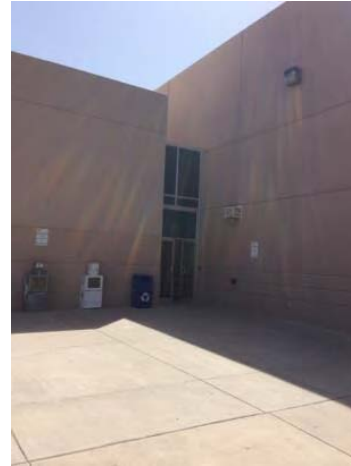
1. No defined main building entry/front door.
2. Potential for exterior study/shade space and trails around desert perimeter.
3. Lack of screen for electrical transformer.

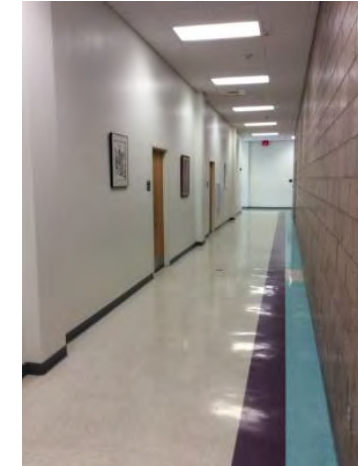
4. No small study spaces on interior.
5. Entry lobby is crowded.
6. Department queuing lines are in main corridor.
7. Restroom locations are not identified
8. Lack of small quiet/study space (in general, at “stack area” and off computer area).
9. Lack of large meeting/commons space for student activity.
10. Handrails are not code compliant
11. Small student dining area.
12. Crowded computer classrooms.
13. No gymnasium or large meeting space.

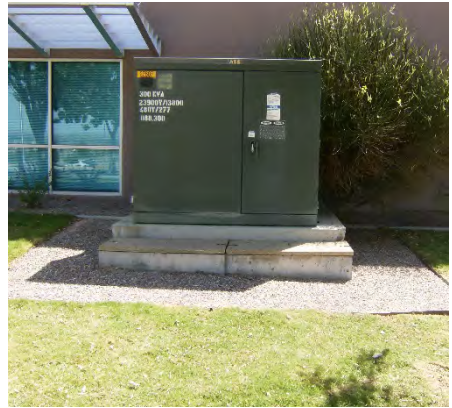
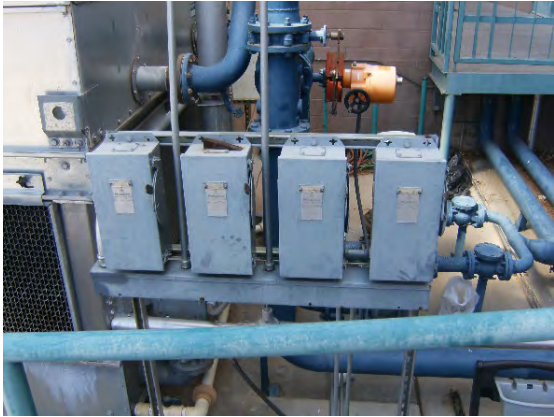
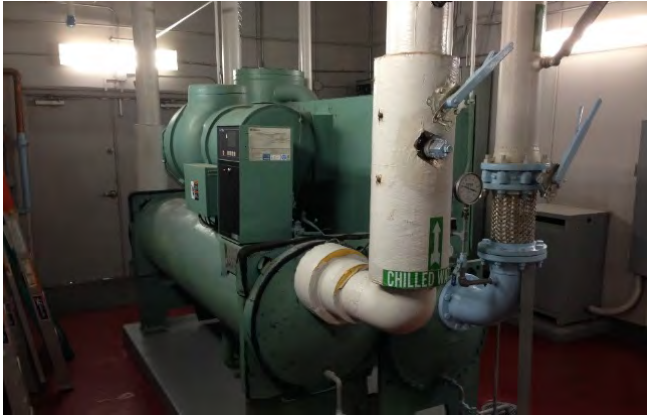
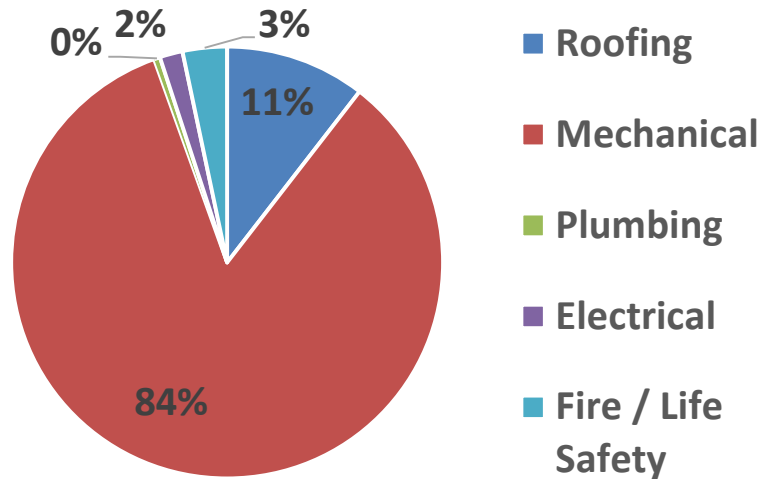
- Chiller, Boiler, Air Cooled Chiller
- Air Handling Units
- Individual Utility metering at Each Building. Elect systems generally in good condition

1 HVAC Chiller & Plant Redundancy

2 Replace roofing

Replace defective FA system devices, exit signs, and lighting fixtures campus-wide

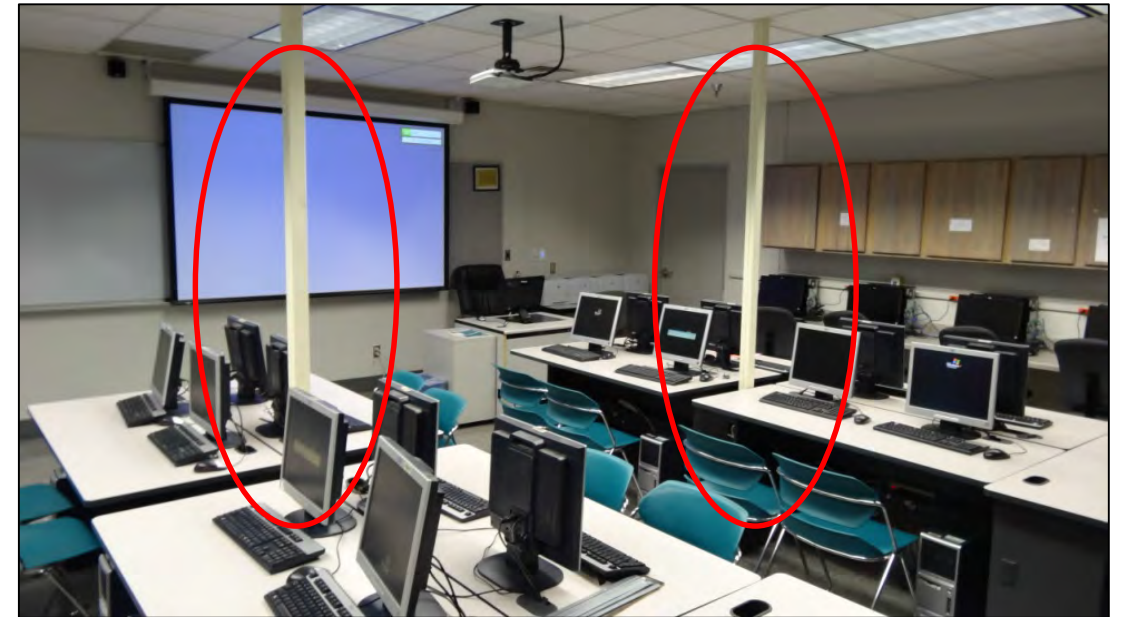
1. Standard smart rooms have a common user interface for control. Non-standard rooms have different control interfaces and unsupported AV equipment.
2. Digital AV connectivity (HDMI) needed in all classrooms to support newer laptops and devices.
3. Observed power poles obstructing sightlines in some teaching spaces.
4. Large number of printers across labs and classrooms would benefit from tracking utilization to reclaim costs and reduce waste.
5. Some computer labs running Windows XP (unsupported).
6. Existing Distance Ed videoconferencing equipment across multiple rooms and campuses no longer used.

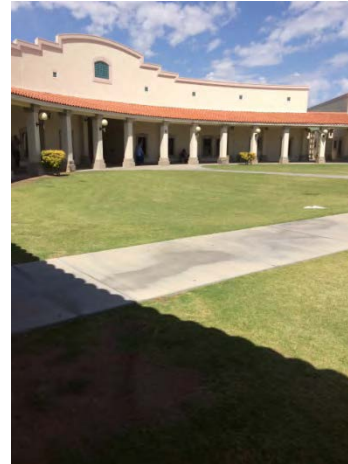
1. One main defined entrance/exit to the campus.
2. Potential for additional exterior hangout space along inside colonnade and to utilize existing building perimeter.

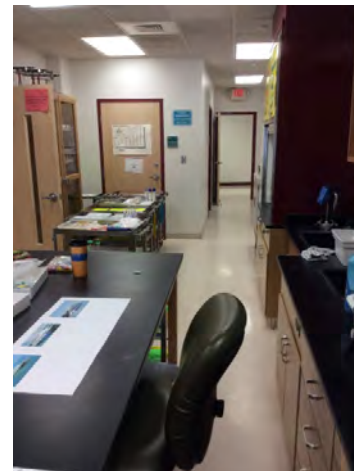
3. No quiet study spaces or gathering spaces; hangout spaces are in corridor; campus needs student union and large meeting space.
4. Existing faculty offices are small/crowded.
5. Classroom/Labs are crowded.
6. No gymnasium; existing weight rooms are small.
7. Some doors equipped with automatic door openers.
8. Potential to use exterior study space off Library.

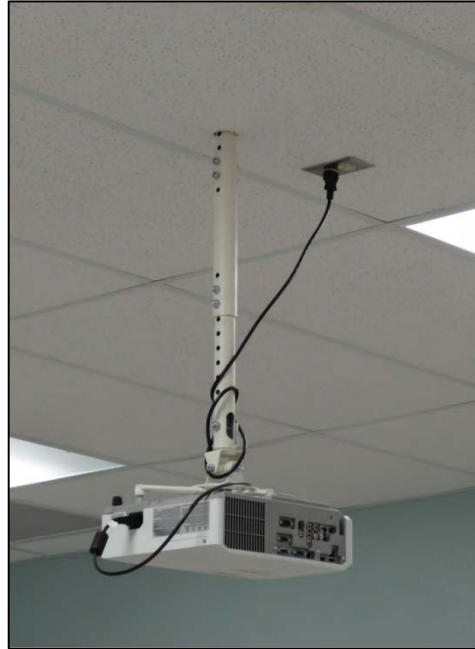
1. AV cabling /connectivity needed or not complete in some areas.
2. Workforce development spaces and some Law Enforcement Academy classrooms need permanent infrastructure to support AV (projection screen, ceiling mounted projector, instructor podium). Mobile equipment is used as a permanent setup.
3. Limited resources in EMT Training. One high fidelity mannequin, few computers, and task trainers for # of users.
4. EMT Training space is constrained and shared for lecture, computer lab use, demonstration, and storage.
